## Photographic Log for Electrolux Major Appliances

<b>Permittee Name:</b> Electrolux Major Appliances		<b>Site Location:</b> 3329 Paul R. Lowry Rd	<b>Tracking No.:</b> TNR153513
---	--	--	-----------------------------------

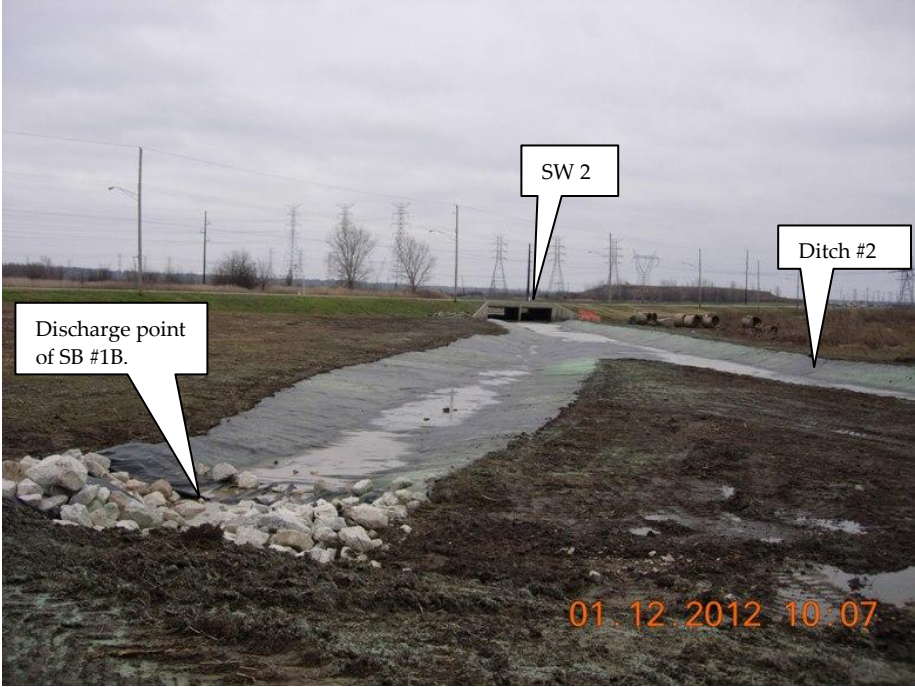
7	1-12-12		
<b>Description</b> Rip rap has been placed at the discharge point of Sediment Basin #1B. Down gradient from the discharge point, the ditch has been lined with the geo-textile fabric. Ditch #2 and the ditch located down gradient from Sediment Basin #1B merge before discharging off-site at Outfall SW 2.

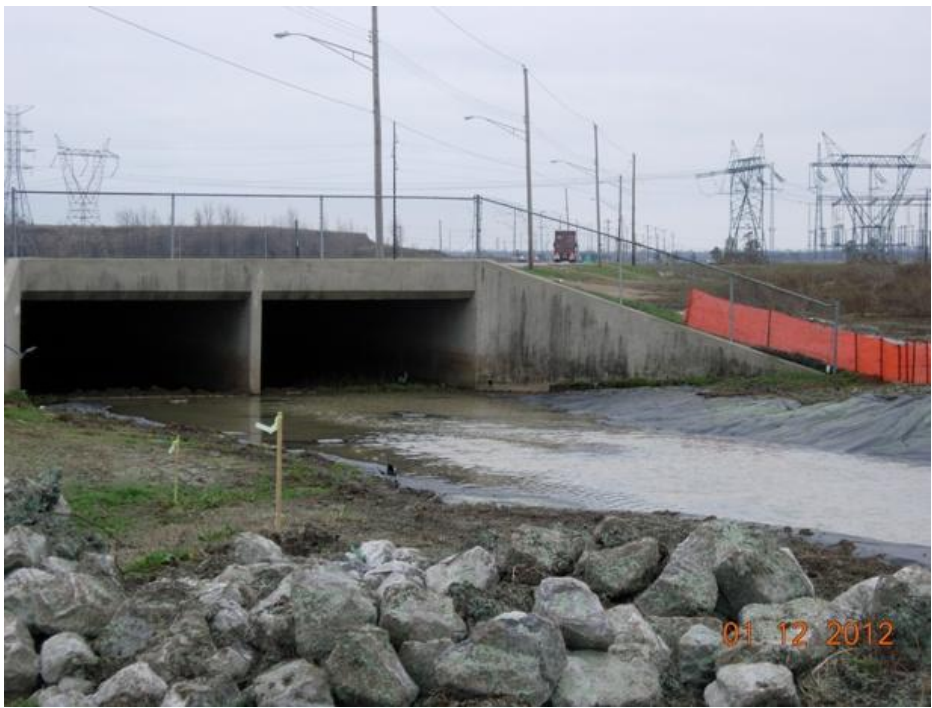
8	1-12-12	
<b>Description</b> A close up view of SW 2 is shown in this photo.

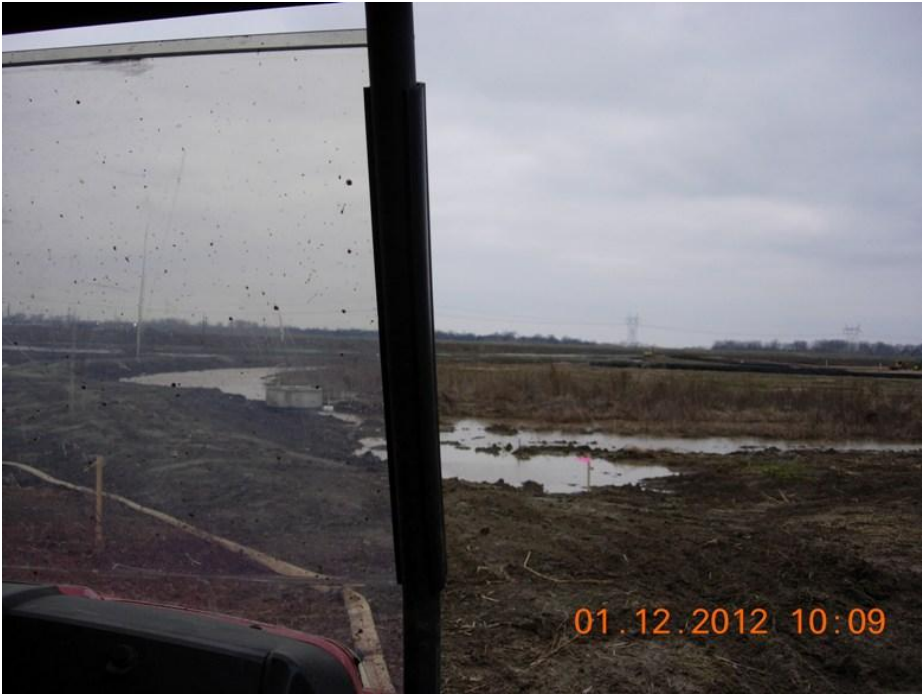
9	1-12-12		
<b>Description</b> Sediment Basin #1A is shown in this photo. The berm between Sediment Basin #1A and #1B has been covered with Bio-Cover. Additional areas around both basins have been covered with Bio-Cover.

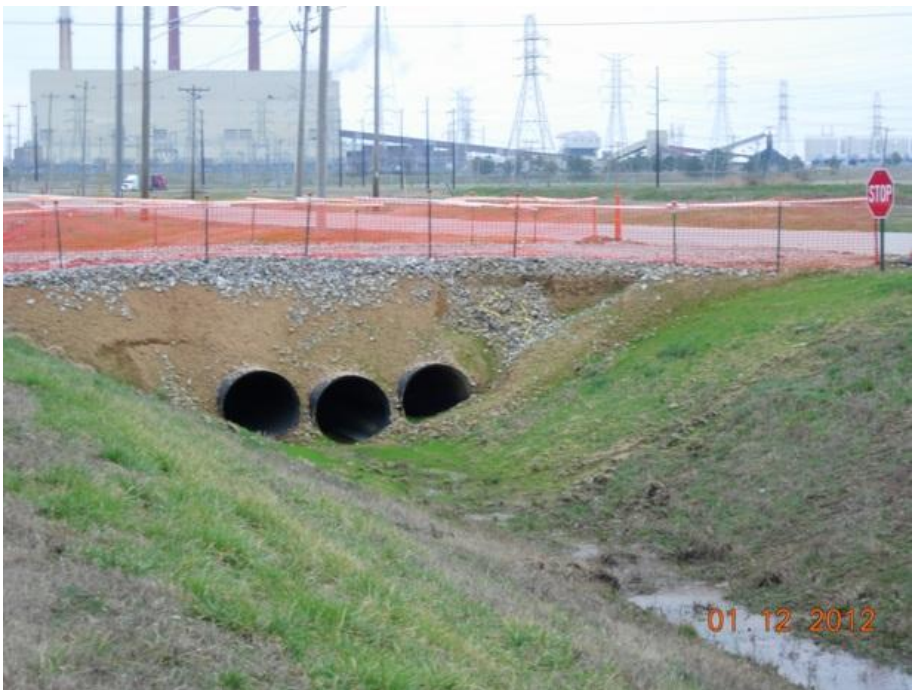
10	1-12-12	
<b>Description</b> Three culverts have been installed under at the construction entrance to the site. The slope adjacent to the three culverts was not sufficiently stabilized. However, no sediment accumulation was observed in the road side ditch along Paul Lowery Road.

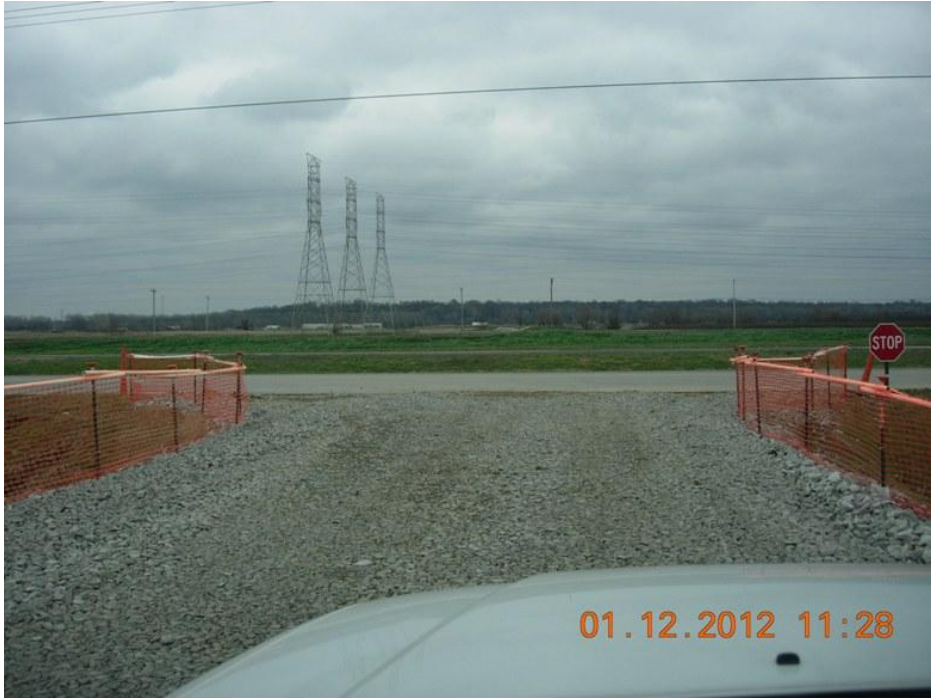
<b>Photo No.</b> 11	<b>Date</b> 1-12-12	<div style="border: 1px solid black; padding: 5px;"> <b>Description</b>          The construction entrance/exit is shown in this photo. At the time of the inspection the entrance/exit appeared to be well maintained and was effectively preventing sediment from being tracked off-site. No sediment was observed tracked onto Paul Lowery Road.       </div>
------------------------	------------------------	--
